UTICA, NEBRASKA

“10-YEAR COMMUNITY VISION” 2011-2021

BLIGHT & SUBSTANDARD DETERMINATION STUDY “Executive Summary”

Village of Utica, Nebraska

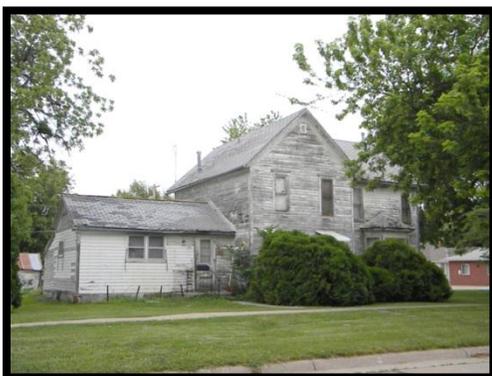
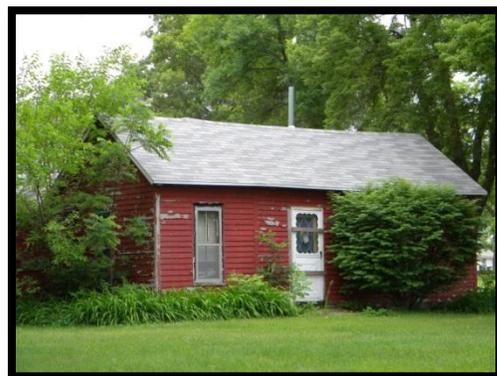
**CONTEXT MAP
REDEVELOPMENT AREA
UTICA, NEBRASKA**

Illustration 1 identifies the **Redevelopment Area** in relation to the Village and land adjacent the Corporate Limits of Utica. An estimated **The Redevelopment Area** includes portions of the right-of-ways of "H" Street (Highway Spur L80F) and Highway 34, and local street right-of-ways within the incorporated area of Utica, generally between Second and Nebraska Streets. Additionally, lands adjacent, but beyond the current Corporate Limits of Utica, Nebraska, include a quarter of a mile width area along the western and eastern Corporate Limits, generally between Highway 34 and the south line of Iowa Street. An estimated 123.8 acres of land within the Corporate Limits of Utica is included in the **Redevelopment Area**, while an additional 314.1 acres of unincorporated lands adjacent, but beyond the Village are also located with the **Area**. **Combined, the total estimated acreage within the Redevelopment Area is 437.9 acres.**

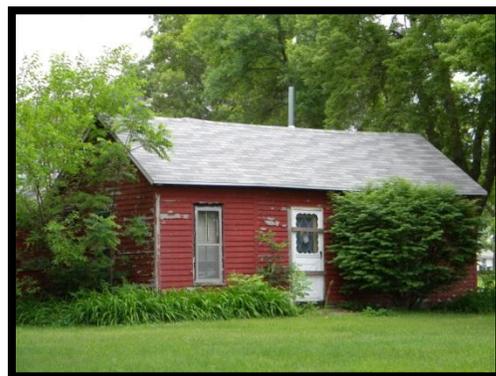
CONTEXT MAP REDEVELOPMENT AREA UTICA, NEBRASKA

Illustration 1 identifies the **Redevelopment Area** in relation to the Village and land adjacent the Corporate Limits of Utica. An estimated **The Redevelopment Area** includes portions of the right-of-ways of "H" Street (Highway Spur L80F) and Highway 34, and local street right-of-ways within the incorporated area of Utica, generally between Second and Nebraska Streets. Additionally, lands adjacent, but beyond the current Corporate Limits of Utica, Nebraska, include a quarter of a mile width area along the western and eastern Corporate Limits, generally between Highway 34 and the south line of Iowa Street. An estimated 123.8 acres of land within the Corporate Limits of Utica is included in the **Redevelopment Area**, while an additional 314.1 acres of unincorporated lands adjacent, but beyond the Village are also located with the **Area**. **Combined, the total estimated acreage within the Redevelopment Area is 437.9 acres.**

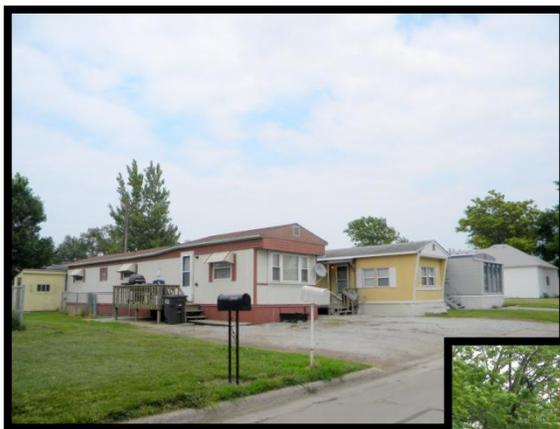
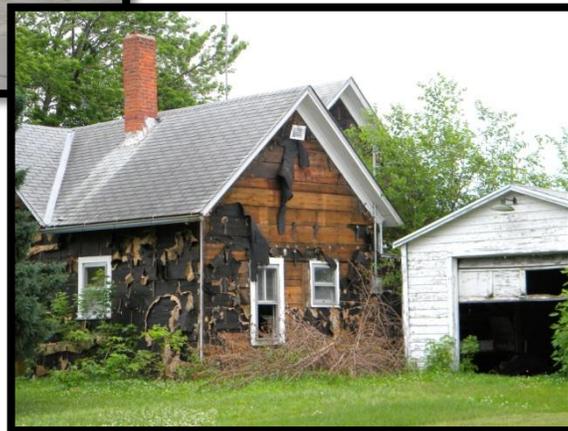
Illustration 1 identifies the **Redevelopment Area** in relation to the Village and land adjacent the Corporate Limits of Utica. The **Redevelopment Area** includes portions of the right-of-ways of "H" Street (Highway Spur L80F) and Highway 34, and local street right-of-ways within the incorporated area of Utica, generally between Second and Nebraska Streets. Additionally, lands adjacent, but beyond the current Corporate Limits of Utica, Nebraska, include a quarter of a mile width area along the western and eastern Corporate Limits, generally between Highway 34 and the south line of Iowa Street.

Major land uses in the **Redevelopment Area** include single family residential, commercial, industrial, and public/quasi-public. The **Redevelopment Area** contains an estimated 437.9 acres, of which approximately 123.8 acres are included within the Corporate Limits of Utica and 314.1 acres of unincorporated lands adjacent but beyond the Village of Utica.

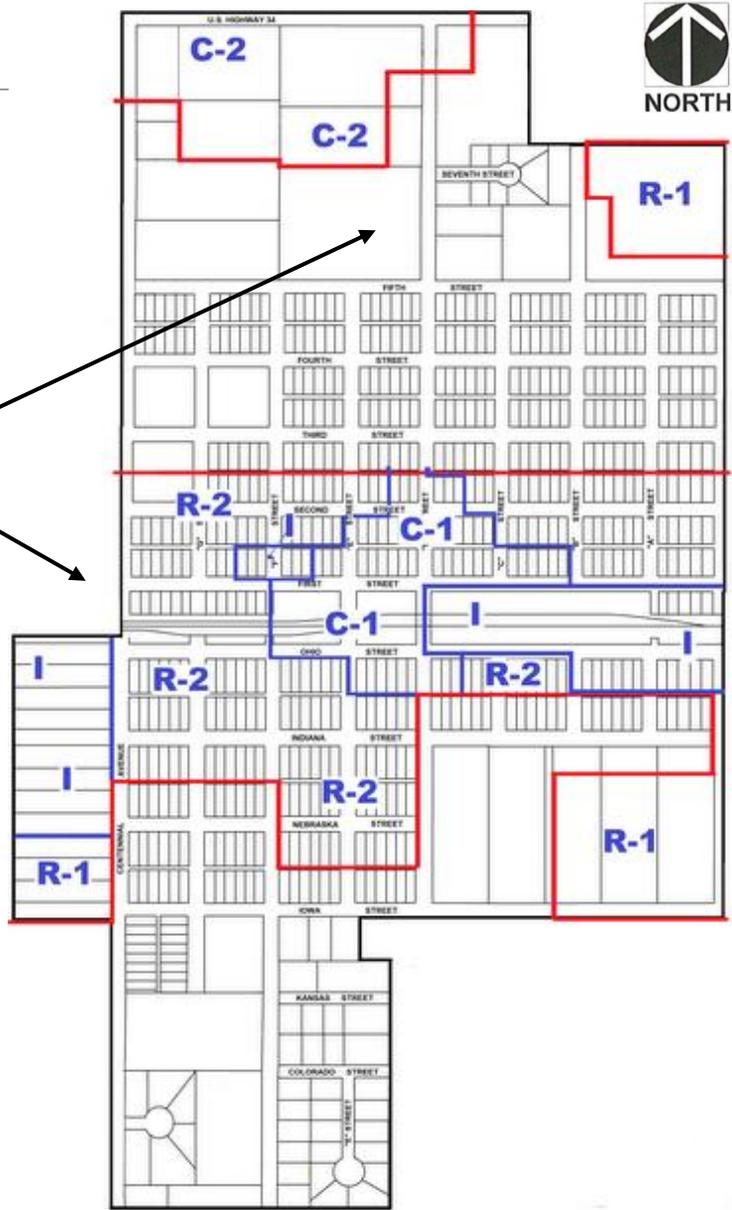
Illustration 3 identifies the current Zoning classifications within the Village of Utica and areas adjacent, but beyond the current Corporate Limits and within the One-Mile Planning Jurisdiction of Utica. Zoning activities throughout the entire **Redevelopment Area**, are controlled by the Village of Utica.

- R-1 LOW-DENSITY RESIDENTIAL
- R-2 MEDIUM-DENSITY RESIDENTIAL
- C-1 GENERAL COMMERCIAL
- C-2 HIGHWAY COMMERCIAL
- I INDUSTRIAL
- ZONING DISTRICT BOUNDARY
- REDEVELOPMENT AREA BOUNDARY

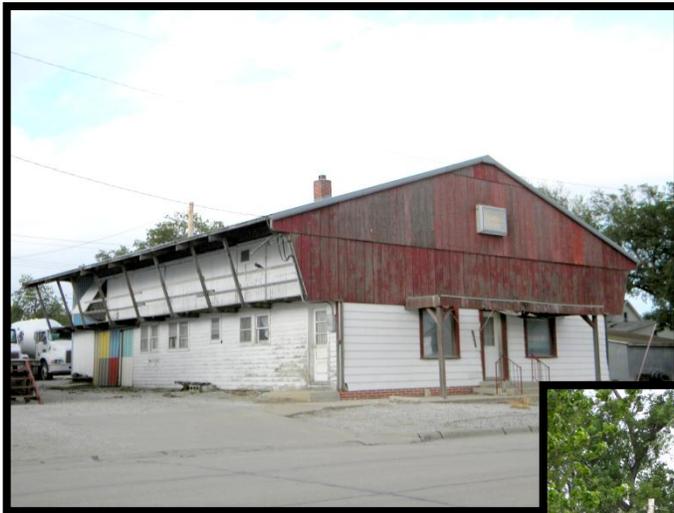
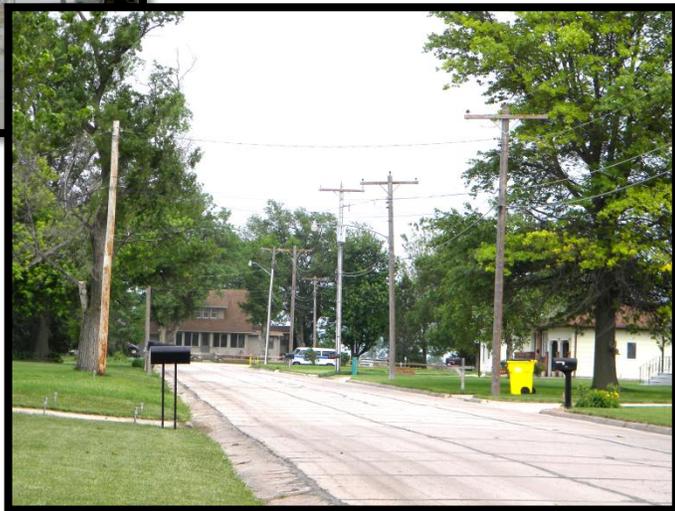
<u>Activity</u>	<u>Sound</u>	<u>Deficient (Minor)</u>	<u>Deteriorating</u>	<u>Dilapidated</u>	<u>Number of Structures</u>	<u>Deteriorating and/ or Dilapidated</u>
Residential	51	20	43	13	127	56
Commercial	5	2	8	7	22	15
Industrial	6	5	3	5	19	8
<u>Other</u>	<u>7</u>	<u>2</u>	<u>3</u>	<u>2</u>	<u>14</u>	<u>5</u>
Totals	69	29	57	27	182	84
Percent	37.9%	15.9%	31.3%	14.8%	100.0%	46.1%

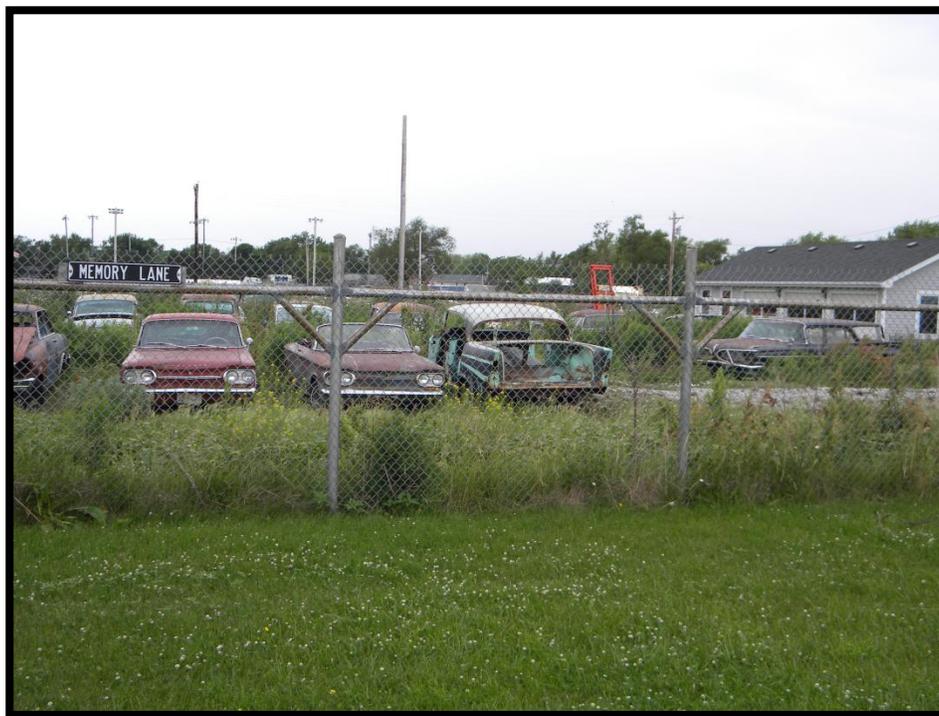
An in-depth analysis of the subdivision conditions in **Redevelopment Area** revealed that improper subdivision and obsolete platting is prevalent throughout the **Area**. Individual lots north of the Burlington Northern Santa Fe Railroad, specifically along First and Second Streets are 44' x 124' (5,456 sq. ft.) or 44' x 101' (4,444 sq. ft.) adjacent the railway corridor. Individual parcels to the south of the railway corridor typically are 44' x 150' (6,600 sq. ft.), which are more typical of the standard lot sizes platted at the end of the 1800s, but are also small by current residential lot size standards. Structures located on these lots within and adjacent Downtown Utica have acquired multiple lots in order to effectively allow placement of a commercial buildings or single family dwellings.
